ENHANCEMENT OF DOD RELATED RESEARCH THROUGH ACQUISITION OF IMPACT TESTIGN EQUIPMENT

**DURIP-97 ENHANCEMENT OF DOD RELATED RESEARCH THROUGH
ACQUISITION OF IMPACT TESTING EQUIPMENT.**

Determination of Damage Tolerance of GFRP Composites Due to Low Velocity Impact

Post-Impact Evaluation of Laminated and Textile Composites

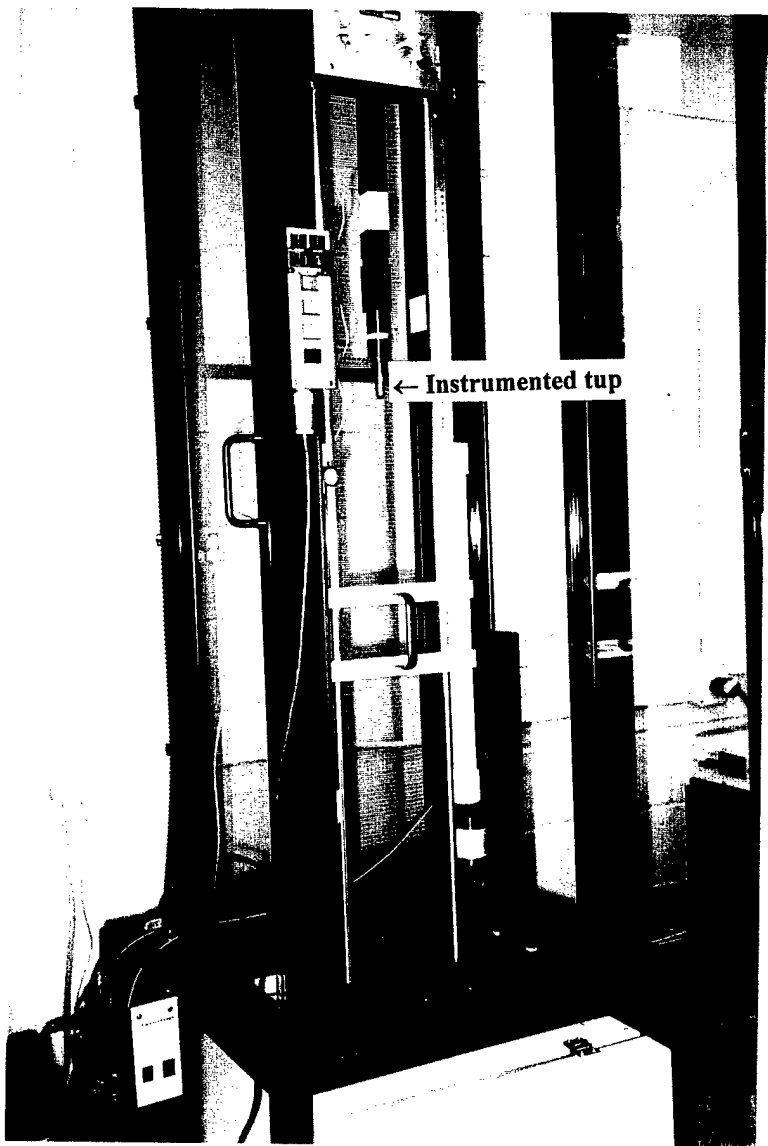
Figure 2. Impact Testing equipment showing instrumented tup.

Complete installation of the above equipment and accessories was completed on Wednesday, January 14, 1998 by Mr. David Smith of Instron company. Figures 1 through 5 respectively show the installed equipment. The institution provided the requisite infrastructure as well as space and technical support towards the successful installation.

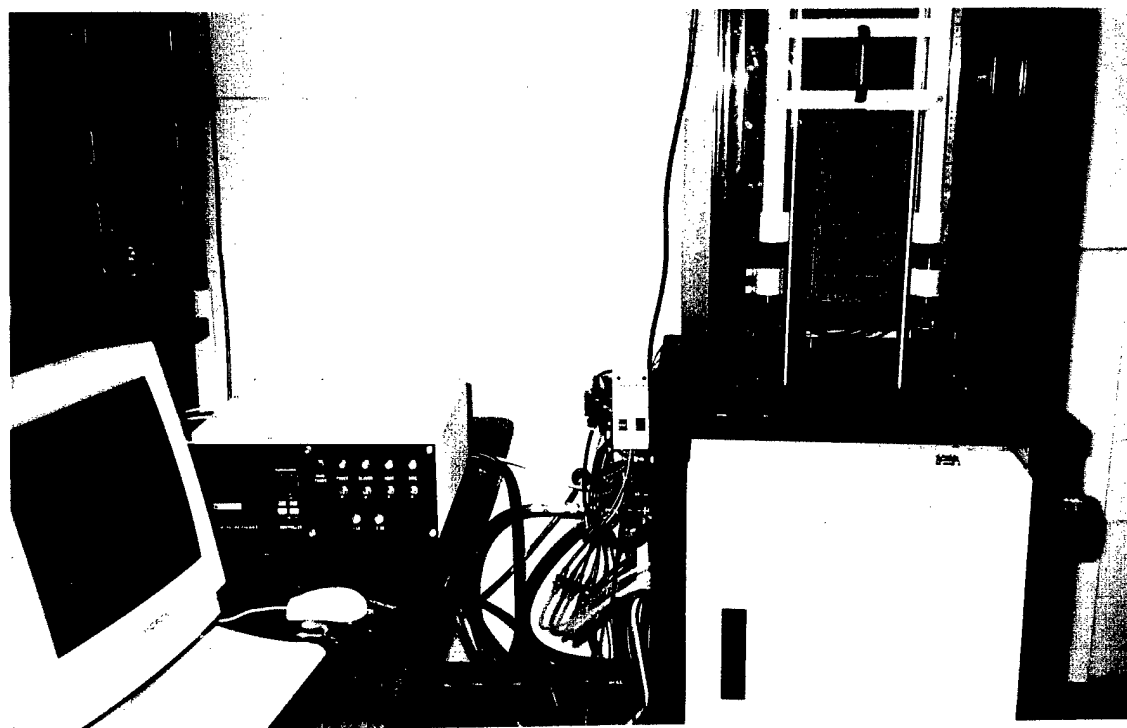
Figure 4. Connected Personal Computer and Data Acquisition system to Impact Testing equipment.
